## Williamson County Oak Brook HOA *Round Rock, TX*

Report #: 38975-0  
Beginning: January 1, 2021  
Expires: December 31, 2021

# RESERVE STUDY

April 4, 2021

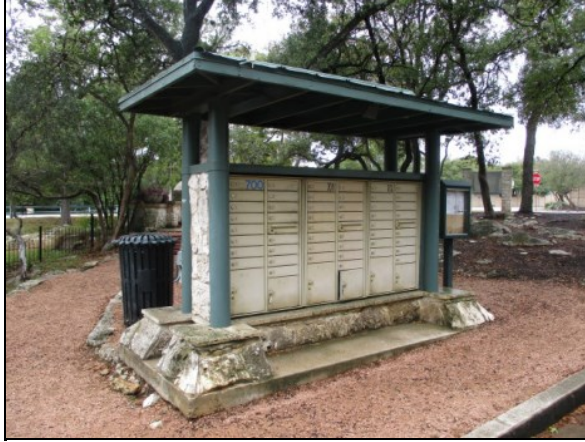
Comments: The association expects to replace the cover roofs and make repairs. Funding provided for expected projects.

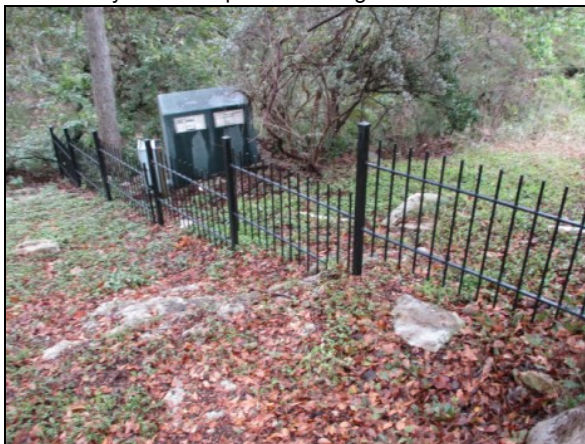
Comments: Metal fencing determined to be in fair condition typically exhibits some minor to moderate amounts of surface wear and other signs of age, which may include corrosion, loose or unstable pieces/sections or hardware, and/or overgrowth by surrounding vegetation. Overall, appears to be in serviceable but declining condition. In our experience, metal fencing will typically eventually break down due to a combination of sun and weather exposure, which is sometimes exacerbated by other factors such as irrigation overspray, abuse and lack of preventive maintenance. For some types of fencing, complete replacement is advisable over recoating or refinishing due to relatively short lifespan of coatings and consideration of total life-cycle cost.

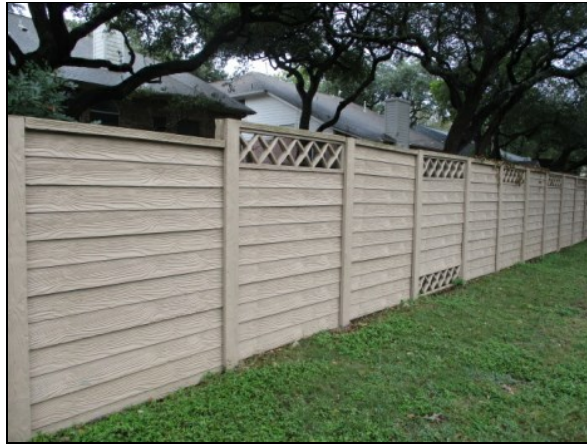
Comments: The fencing was painted in 2018. Good conditions observed at this time. Expect a full useful life.

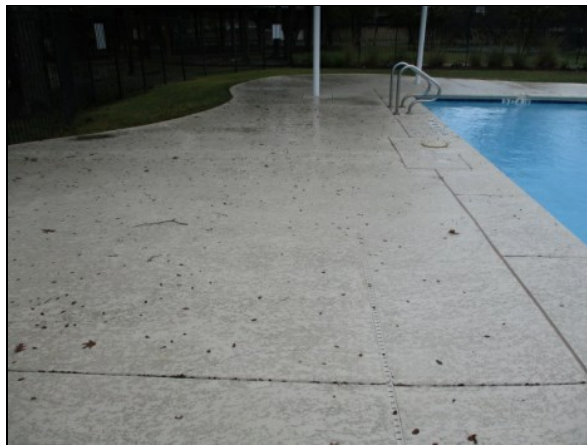
Comments: The decking surfaces are in good condition at this time. Pool decks may be exposed to harsh chemicals that can leave stains if not addressed properly. Periodic pressure-washing and re-coating will restore the appearance and prolong the need for major restoration or replacement of the deck surface. Take note of any places where water is ponding, which may result in slip-and-fall hazards if not corrected.
