## Williamson County Oak Brook HOA *Round Rock, TX*

Report #: 38975-0  
Beginning: January 1, 2021  
Expires: December 31, 2021

# RESERVE STUDY

April 4, 2021

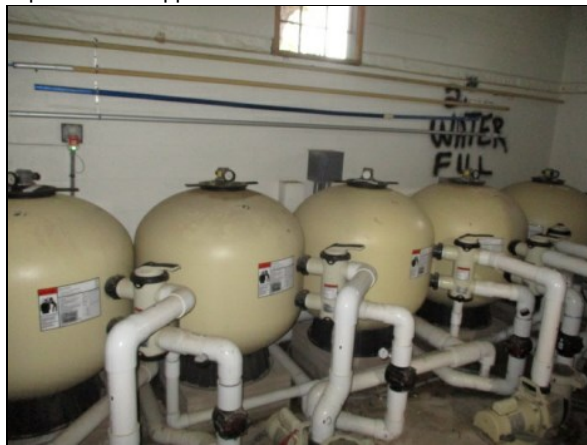
**Comp #: 1207 Pool Filters - Replace****Quantity: (5) Sand Filters**

Comments: Filters are intact and in good condition. No issues noted. Pool vendor should inspect regularly for optimal performance and address any repairs or preventive maintenance as needed. Life can vary depending on location, as well as level of use and preventive maintenance. Plan to replace at the approximate interval shown below.

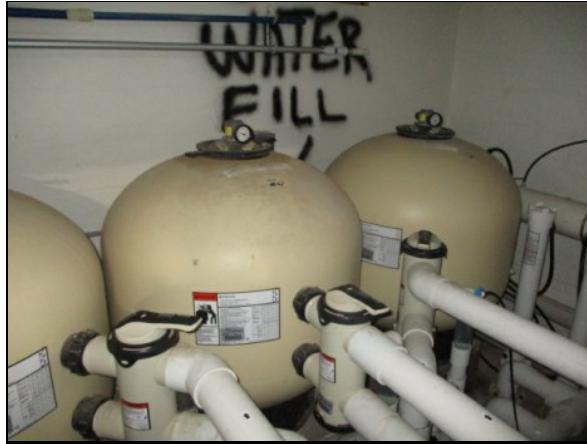
**Comp #: 1208 Sand Filters - Replace Media****Quantity: (5) Sand Filters**

Comments: It is recommended that the media within the filters be inspected and replaced on a regular basis. Recommendations for timing and media type should be acquired by your service provider. Often times the media within the filter will have to be cleaned or replaced due to build-up and flow issues. This project is beneficial for the longevity of the filter system and can greatly effect the efficiency of the overall system.

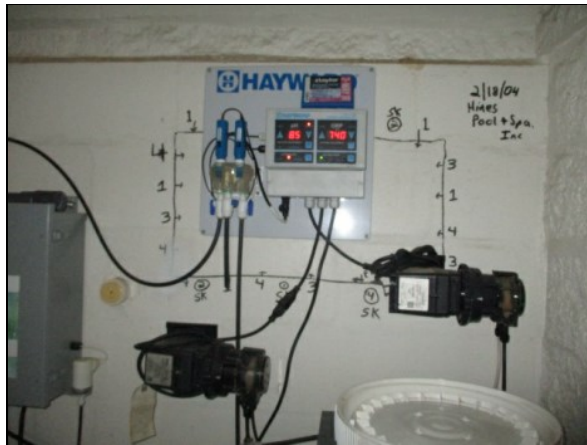
**Comp #: 1209 Chemical Controller - Replace****Quantity: (1) System**

Comments: The chemical controllers were not tested during inspection, but are assumed to be functional. No reported issues at this time. Funding has been provided for the periodic replacement of control panels and motors following roughly the schedule below.

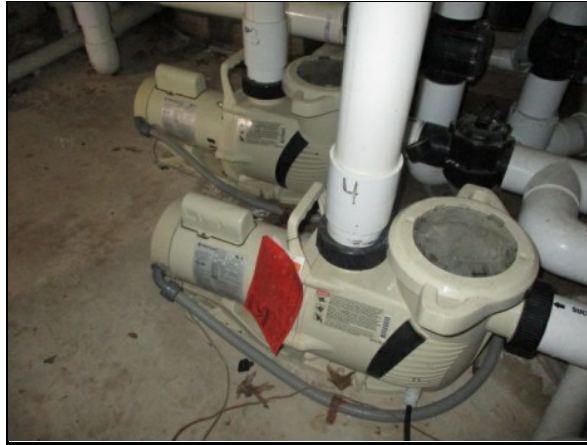
**Comp #: 1210 Pool Pumps - Replace****Quantity: (5) Pumps**

Comments: Pumps are in good condition. Pumps should be inspected regularly for leaks and other mechanical problems. Cost shown is based on replacement with the same type and size unless otherwise noted, and includes small allowance for new piping/valves/other repairs as needed.

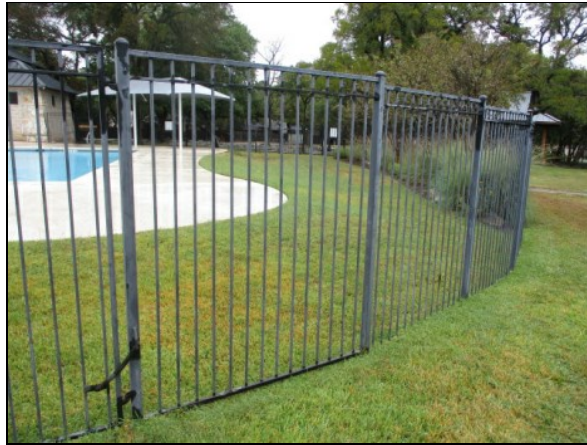
**Comp #: 1225 Pool Perimeter Fence - Replace****Quantity: ~ 525 LF**

Comments: Metal fencing determined to be in fair condition typically exhibits some minor to moderate amounts of surface wear and other signs of age, which may include corrosion, loose or unstable pieces/sections or hardware, and/or overgrowth by surrounding vegetation. Overall, appears to be in serviceable but declining condition. In our experience, metal fencing will typically eventually break down due to a combination of sun and weather exposure, which is sometimes exacerbated by other factors such as irrigation overspray, abuse and lack of preventive maintenance. For some types of fencing, complete replacement is advisable over recoating or refinishing due to relatively short lifespan of coatings and consideration of total life-cycle cost.

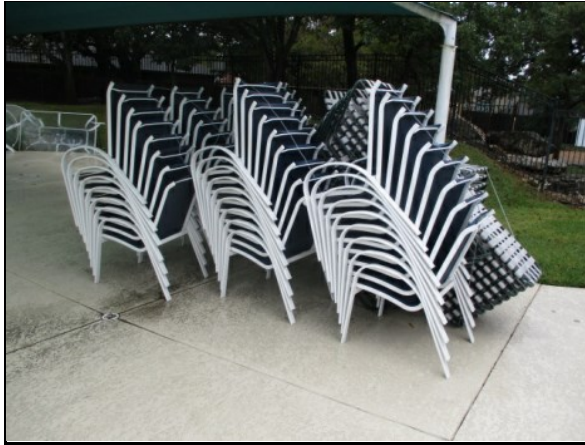
**Comp #: 1230 Pool Furniture - Replace**

Comments: Includes: (15) tables, (52) chairs, and (20) chaise lounges. Pool furniture is determined to be in good condition. Normal wear and aging noted at this time. No signs of rips or tears in fabric/straps. Best to replace all of the pieces at the same time in order to maintain a uniform appearance.

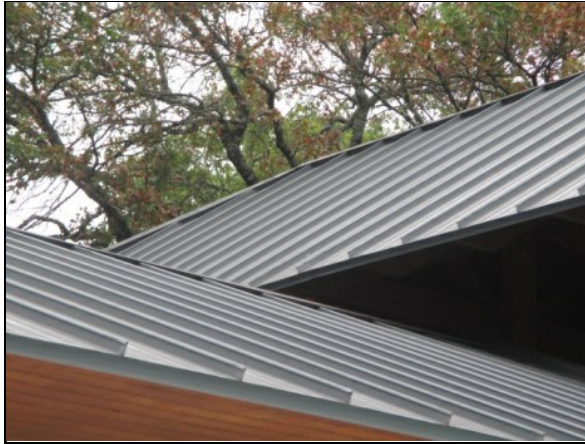
**Comp #: 1308 Metal Roof - Replace****Quantity: ~ 2,280 GSF**

Comments: The roof is in fair condition at this time. No reports of water intrusion. The timeline for metal roof replacement is generally estimated based on the age of the roof. Remaining useful life can also be adjusted based on inspection of any accessible areas, looking for any damaged or lifting sections, signs of advanced corrosion or wear to panels and hardware, as well as consultation with the client about history of repairs and preventive maintenance. Advantages of metal roofs include long life expectancies with relatively low need to repair. Metal roofing is typically a long-lived component assuming it was properly installed and is properly maintained. As routine maintenance, many manufacturers recommend inspections at least twice annually and after large storm events. Promptly replace any damaged/missing sections or conduct any other repair needed to ensure waterproof integrity of roof. We recommend having roof inspected in greater detail (including conditions of sub-surface materials) by an independent roofing consultant prior to replacement. There is a wealth of information available through organizations such as the Roof Consultant Institute <http://www.rci-online.org/> and the National Roofing Contractors Association (NRCA) <http://www.nrca.net/>. If the roof has a warranty, be sure to review terms and conduct proper inspections/repairs as needed to keep warranty in force.

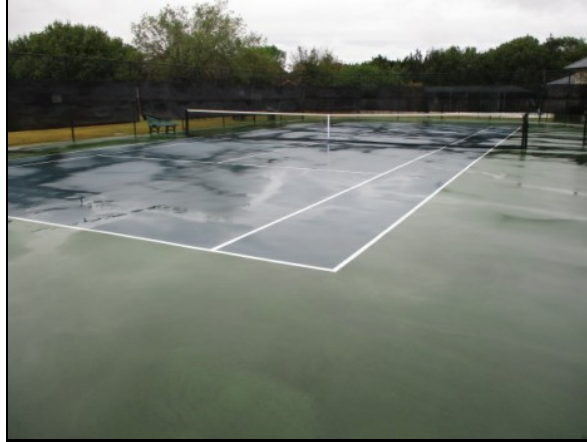
Comments: The courts are in fair condition at this time. Assuming proper maintenance and proper re-coating schedules, the court surface should have a relatively long life expectancy. Over time, exposure to UV light, wind rain and foot traffic will deteriorate the surface to the point of failure. Prior to resurfacing, consult with vendors to identify any structural problems, such as poor grade, lack of drainage, high spots, etc. Plan to resurface at the approximate interval shown below in order to preserve the appearance and usefulness of the court surface. Best practice is to coordinate with other projects, such as fencing and/or lighting replacement.

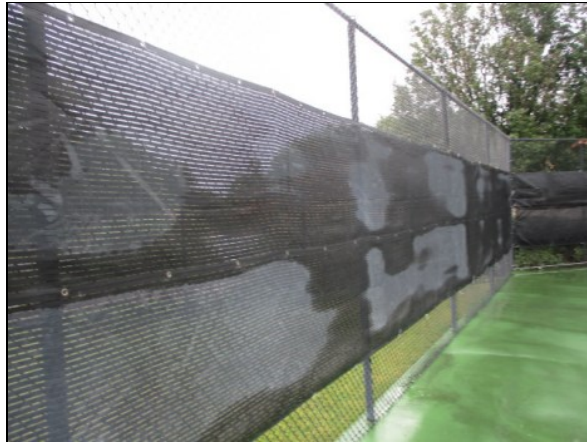
**Comp #: 1605 Windscreens - Replace****Quantity: ~ 340 LF**

Comments: Windscreens are in fair condition. Tennis court windscreens should be inspected periodically, especially where attached to the chain link to identify and repair any rips or tears. Loose/sagging/faded sections should be replaced to maintain good aesthetic appearance in the common areas. Plan to replace all areas together at the approximate interval shown here to maintain consistent appearance.
